## A review of aeronautical fatigue investigations in Finland April 2011 - February 2013

Siljander, A. (Ed.) (2013). *A review of aeronautical fatigue investigations in Finland April 2011 - February 2013*. VTT Technical Research Centre of Finland. ICAF National Review - Finland No. 2428VTT Research Report No. VTT-R-0215-13

**A REVIEW OF AERONAUTICAL FATIGUE  
INVESTIGATIONS IN FINLAND  
APRIL 2011 – FEBRUARY 2013**

Presented at the 33<sup>rd</sup> Conference of the  
International Committee on Aeronautical Fatigue and  
Structural Integrity (ICAF),  
Jerusalem, Israel, 3-4 June 2013

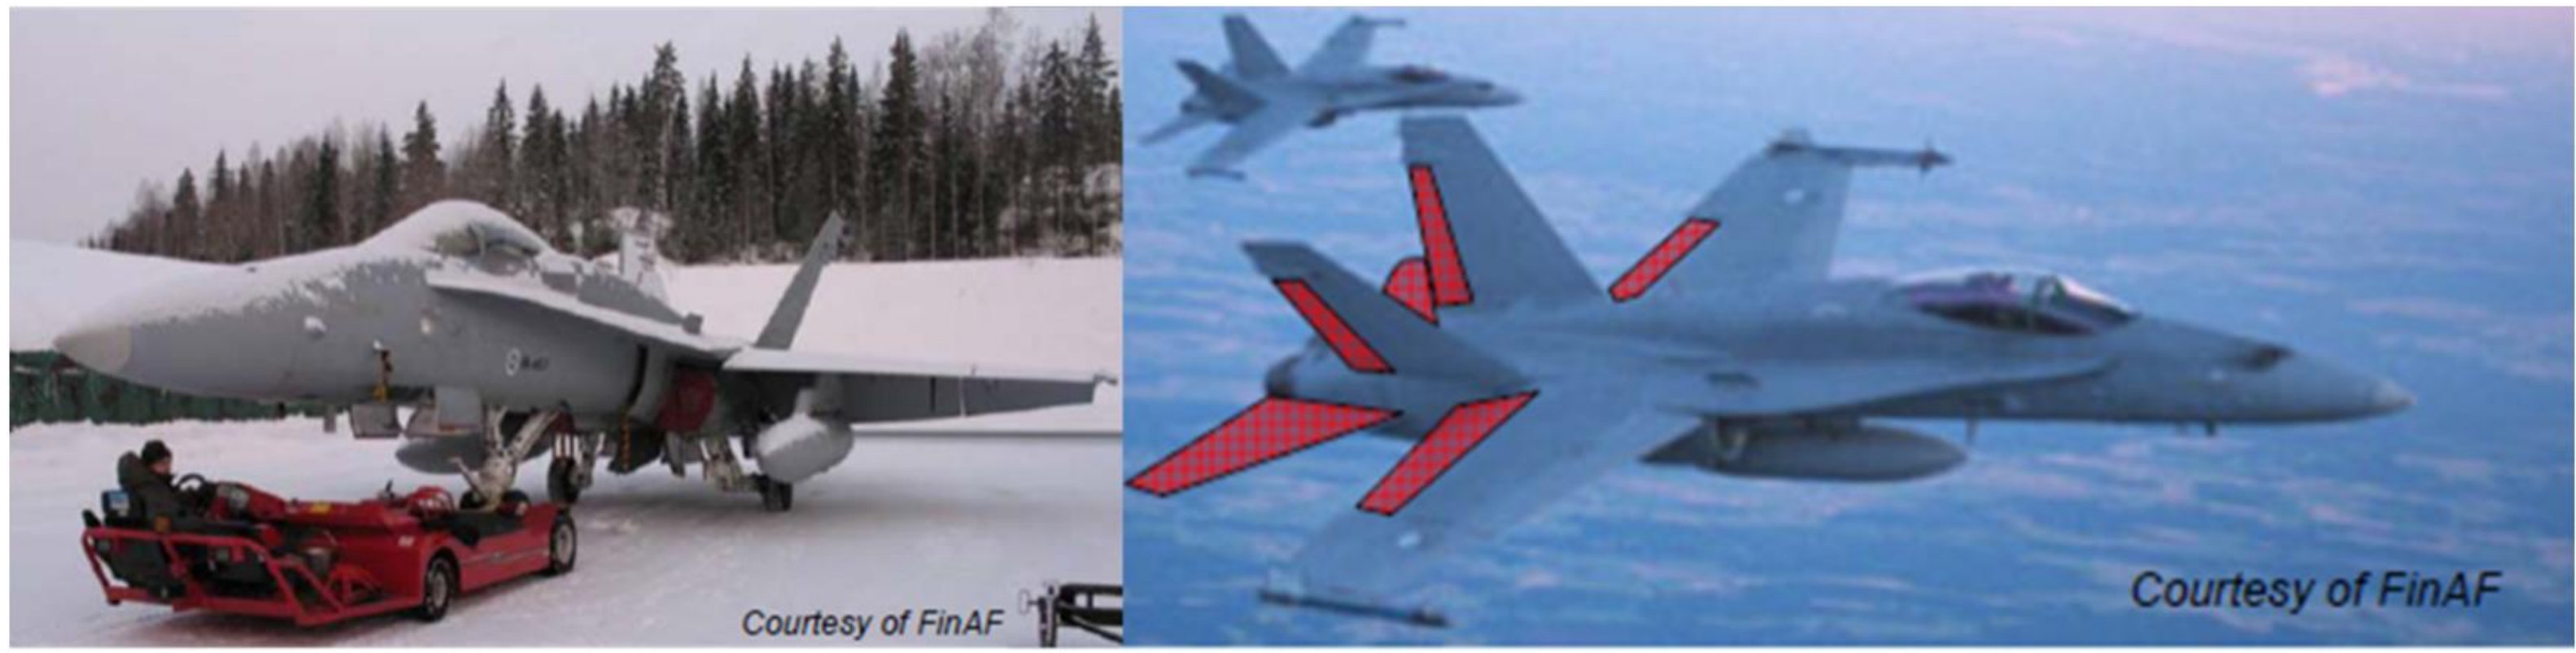
**Figure 20:** *The optimal thermographic inspection exploiting phase transition of water. **Left:** To succeed in the thermographic inspections, it is of paramount importance to ensure adequate cooling (freezing) of the aircraft before starting of the measurements. **Right:** The inspection consisted of six different flight surfaces (10 locations) in one sequence of inspection checks. Picture by courtesy of the FINAF.*

The target of the work was to find a suitable procedure to detect penetrated water from the composite aircraft structures by using thermographic investigation method exploiting the phase transition of water. Previous thermographic activities were highlighted in [4 Chapter 13.2.3.1]. Since then, it was verified that 6 different flight surfaces (10 positions), **Fig. 20**, can be inspected during one inspection route at optimal temperature range with the developed thermographic method. One inspection route consists of rudder, trailing edge flap (around the middle and the main hinges) and horizontal stabilizer (pinion and main hinge) from both sides of the aircraft.
